# III.B

## Ecology and Natural Resources

**25 Old Mill Road, Suffern, NY**

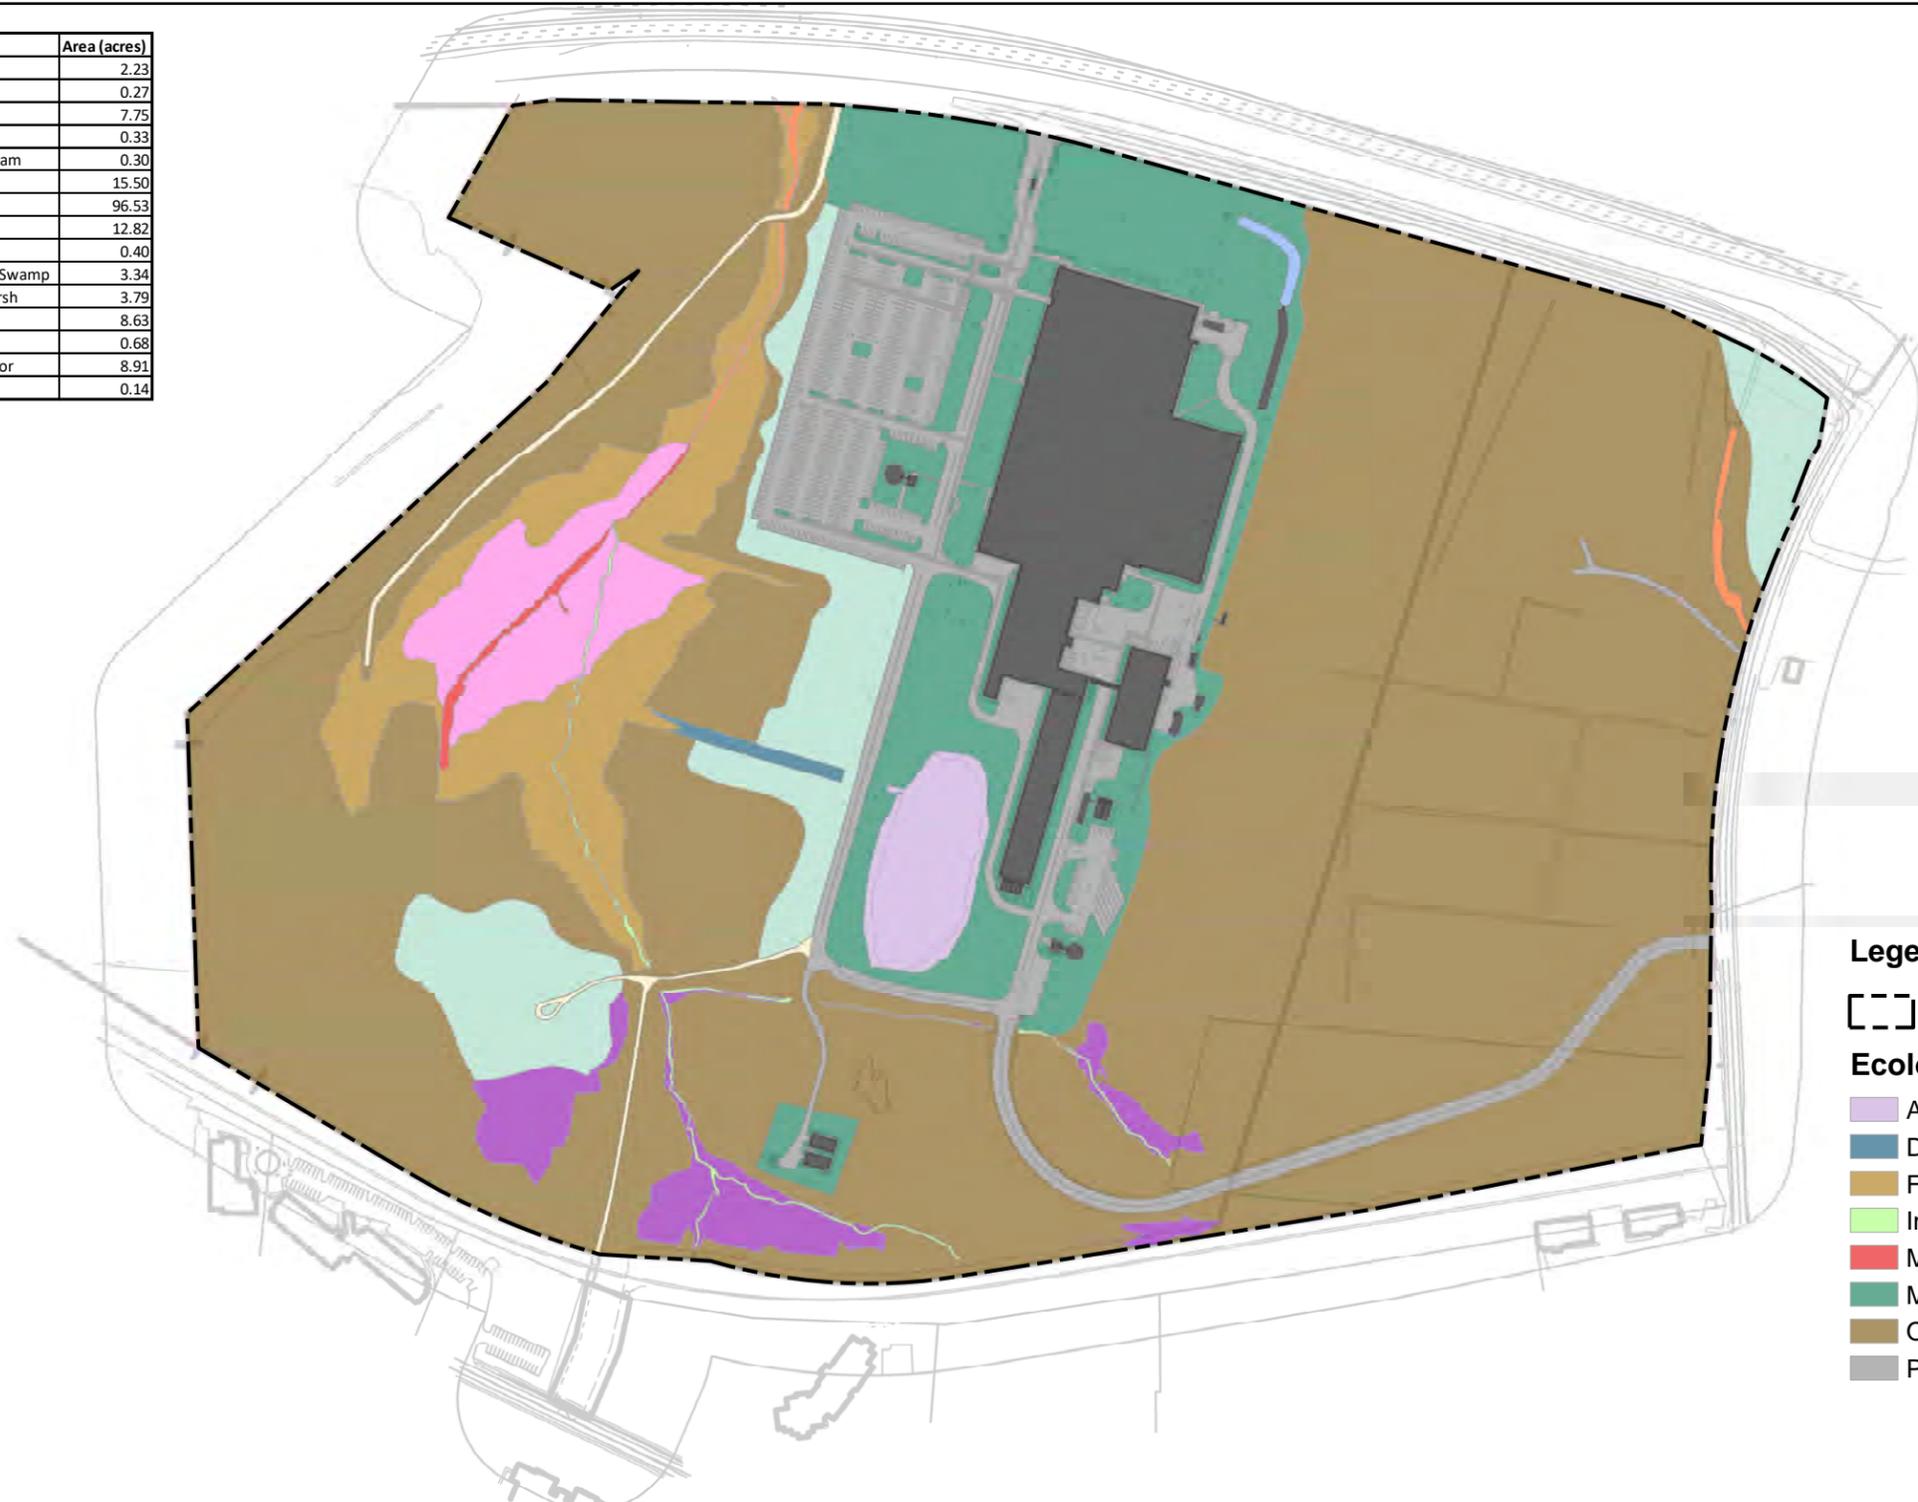
A total of 15 ecological communities were identified on the Study Area based on the Ecological Communities of New York State (**Figure III.B-3**).<sup>4</sup> As portions of the Subject Property have been fairly undisturbed and others significantly disturbed and shaped by surrounding development activities, a number of ecological communities, of varying size and characteristics were identified based on the Natural Resource inventories (NRI) surveys; wetland delineations, classification system outlined in the *Ecological Communities of New York State* (Edinger *et al.* 2014);<sup>5</sup> and the investigating team's experience and familiarity with the site.<sup>6</sup> Terrestrial, palustrine, lacustrine, and riverine communities were determined to be present within the Project Site and the various vegetative cover types found throughout the Study Area were characterized. Utilizing NRI data collected at the 18 sample points, a detailed ecological communities map was generated (**Figure III.B-3**).

Description	Area (acres)
Artificial Pond	2.23
Ditch	0.27
Floodplain Forest	7.75
Intermittent Stream	0.33
Marsh Headwater Stream	0.30
Mowed Lawn	15.50
Oak Tulip Forest	96.53
Paved Roads	12.82
Perennial Stream	0.40
Red Maple Hardwood Swamp	3.34
Shallow Emergent Marsh	3.79
Successional Old Field	8.63
Unpaved Path	0.68
Urban Structure Exterior	8.91
Water Recharge Basin	0.14

community containing predominantly native vegetation. As depicted in **Figure III.B-3**, Ecological Communities, approximately 7.75 acres (4.8 percent) of the Subject Property is classified as the floodplain forest.

Ecological Communities, approximately 0.30 acres (0.2 percent) of the Subject Property is classified as the marsh headwater stream.

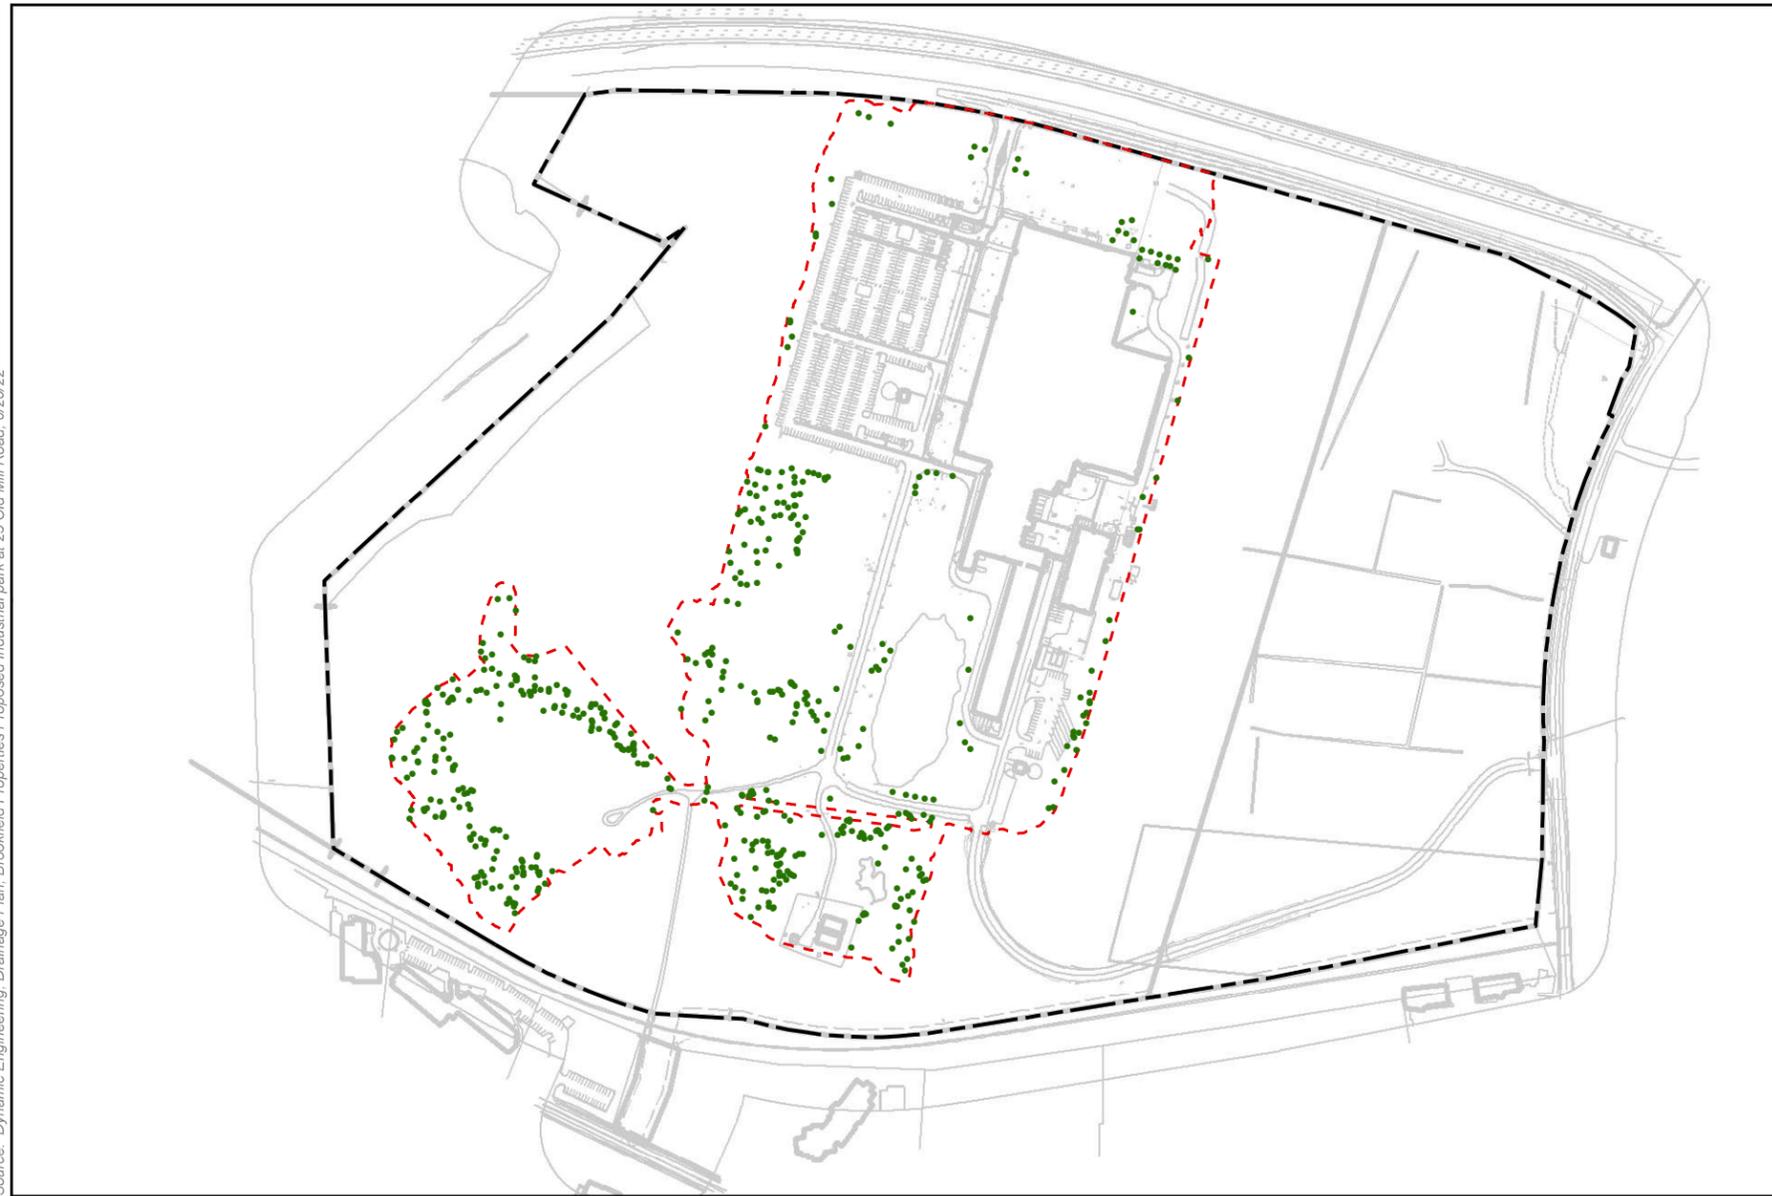
**Tree Study**  
**Figure III.B-4**

The property was field-surveyed to identify all trees with a minimum 12-inch diameter at breast height measured four feet from the ground. The location and size of these trees are represented on the property survey as well as the Existing Conditions Plan within the Preliminary and Final Major Site Plan drawings. Refer to **Figure III.B-4** for locations. The survey was non-invasive as it was strictly field observation and did not result in the disturbance to any existing habitats in the area. **Table III.B-1** lists the observed species of vegetation identified within the wetland and terrestrial ecological communities during the natural resource inventory field visits.

- 534 Trees with a dbh of 12" or greater within the Limit of Disturbance
- - - Limit of Disturbance
- - - Site Boundary

The property was field-surveyed to identify all trees with a minimum 12-inch diameter at breast height measured four feet from the ground. The location and size of these trees are represented on the property survey as well as the Existing Conditions Plan within the Preliminary and Final Major Site Plan drawings. Refer to **Figure III.B-4** for locations. The survey was non-invasive as it was strictly field observation and did not result in the disturbance to any existing habitats in the area.

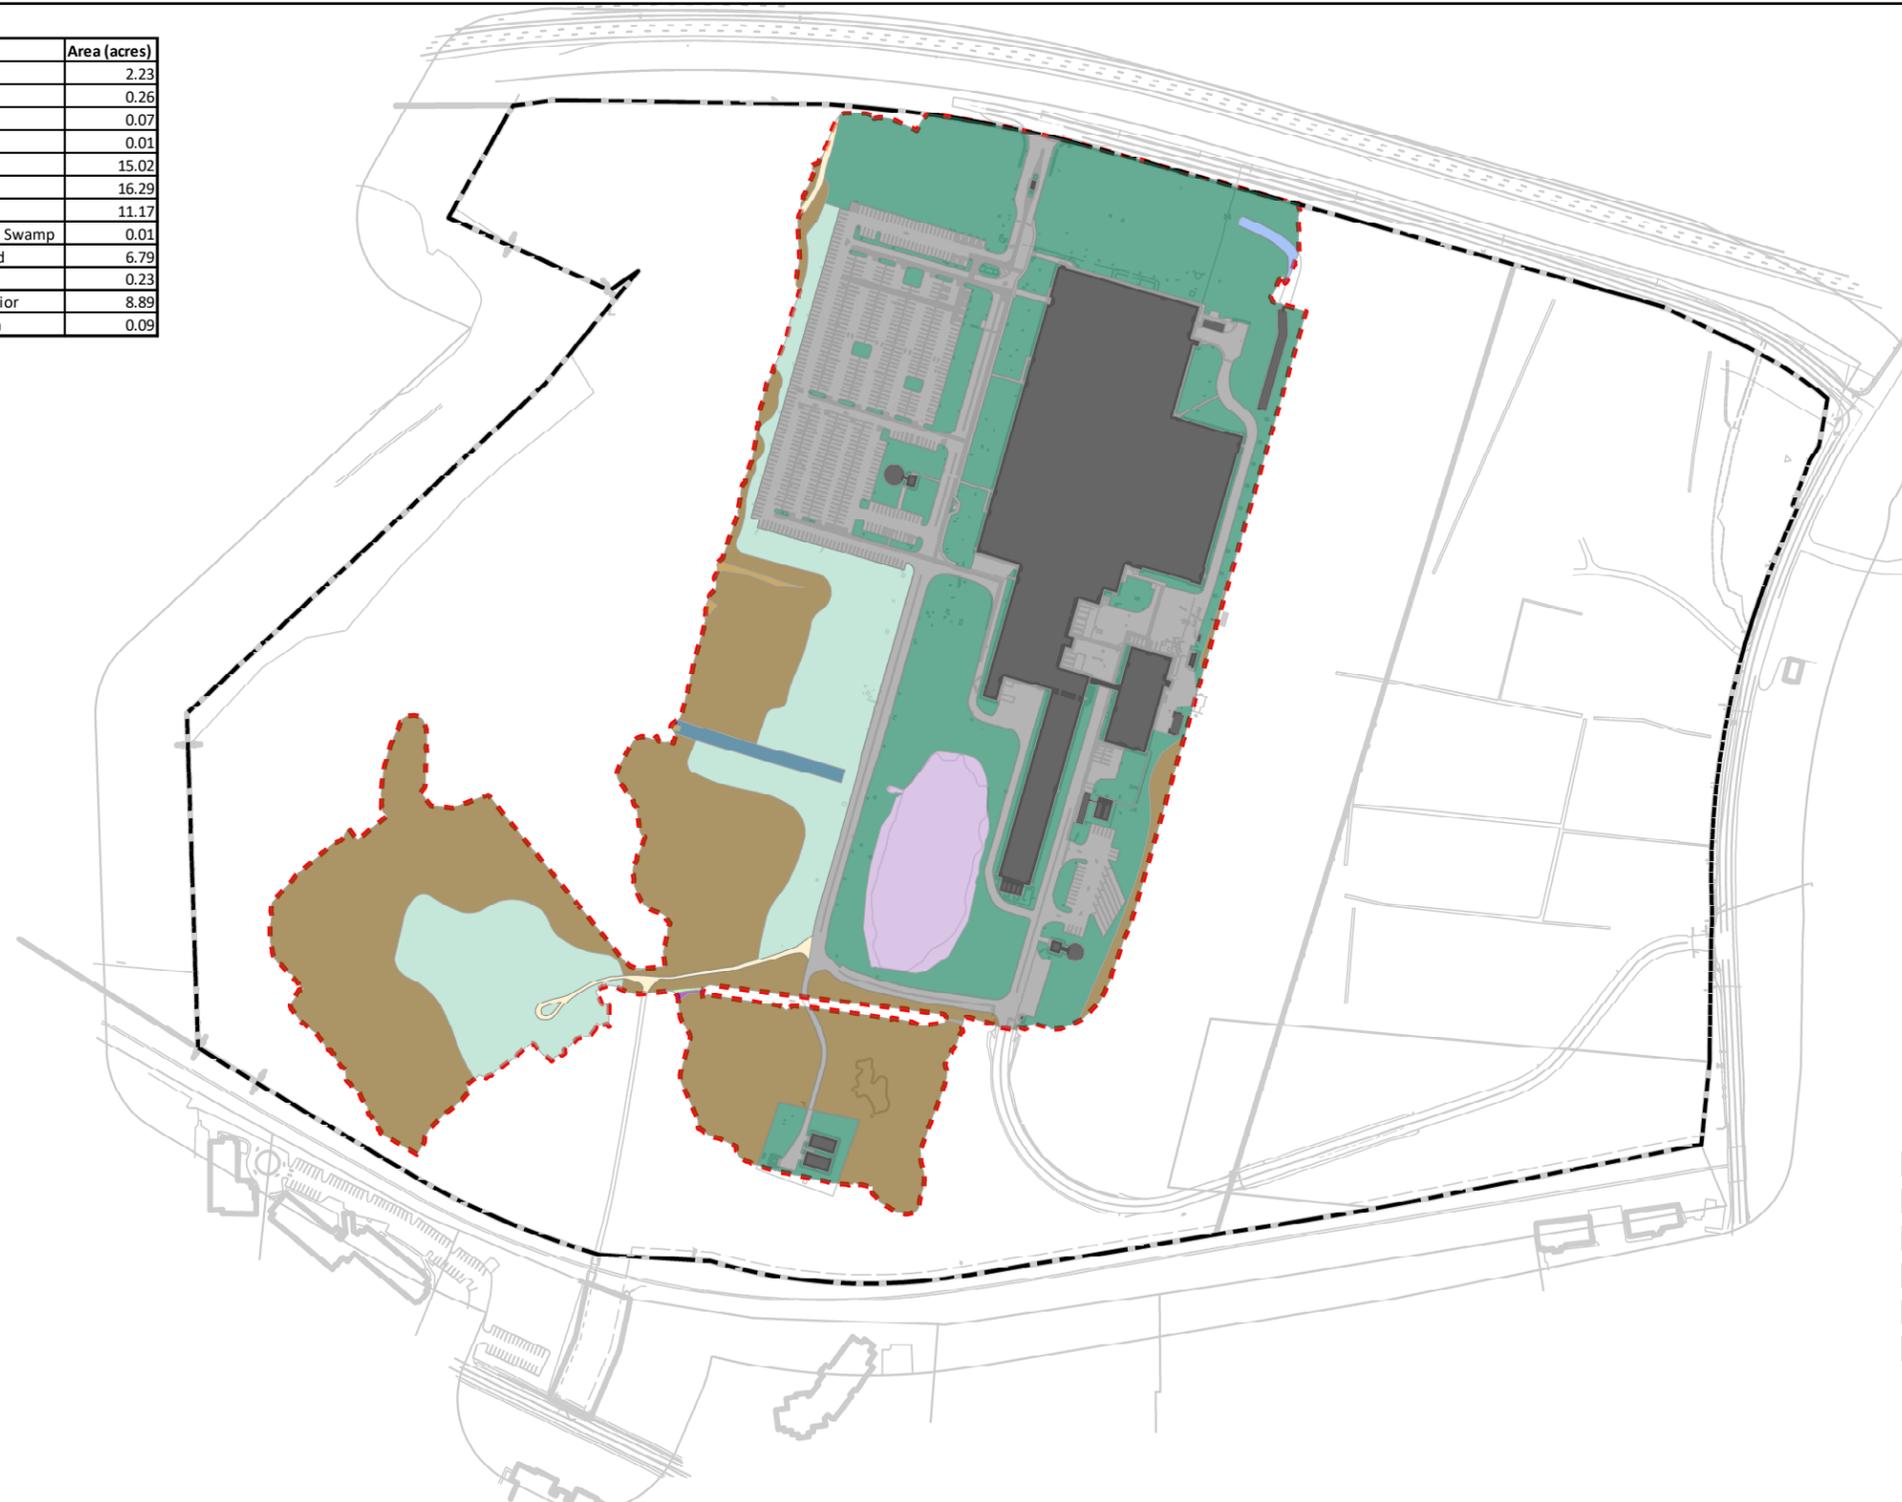
- › 16.29 acres of oak-tulip tree forest,
- › 6.79 acres of successional old field,
- › 15.02 acres of mowed lawn,
- › 0.23 acres of unpaved path,
- › 11.17 acres of paved road,
- › 8.89 acres of urban structure exterior,
- › 0.01 acres of red maple-hardwood swamp,
- › 0.07 acres of floodplain forest,
- › 0.09 acres of water recharge basin,
- › 0.01 acres of intermittent stream,
- › 0.26 acres of ditch, and
- › 2.23 acres of artificial pond.

Description	Area (acres)
Artificial Pond	2.23
Ditch	0.26
Floodplain Forest	0.07
Intermittent Stream	0.01
Mowed Lawn	15.02
Oak Tulip Forest	16.29
Paved Roads	11.17
Red Maple Hardwood Swamp	0.01
Successional Old Field	6.79
Unpaved Path	0.23
Urban Structure Exterior	8.89
Water Recharge Basin	0.09

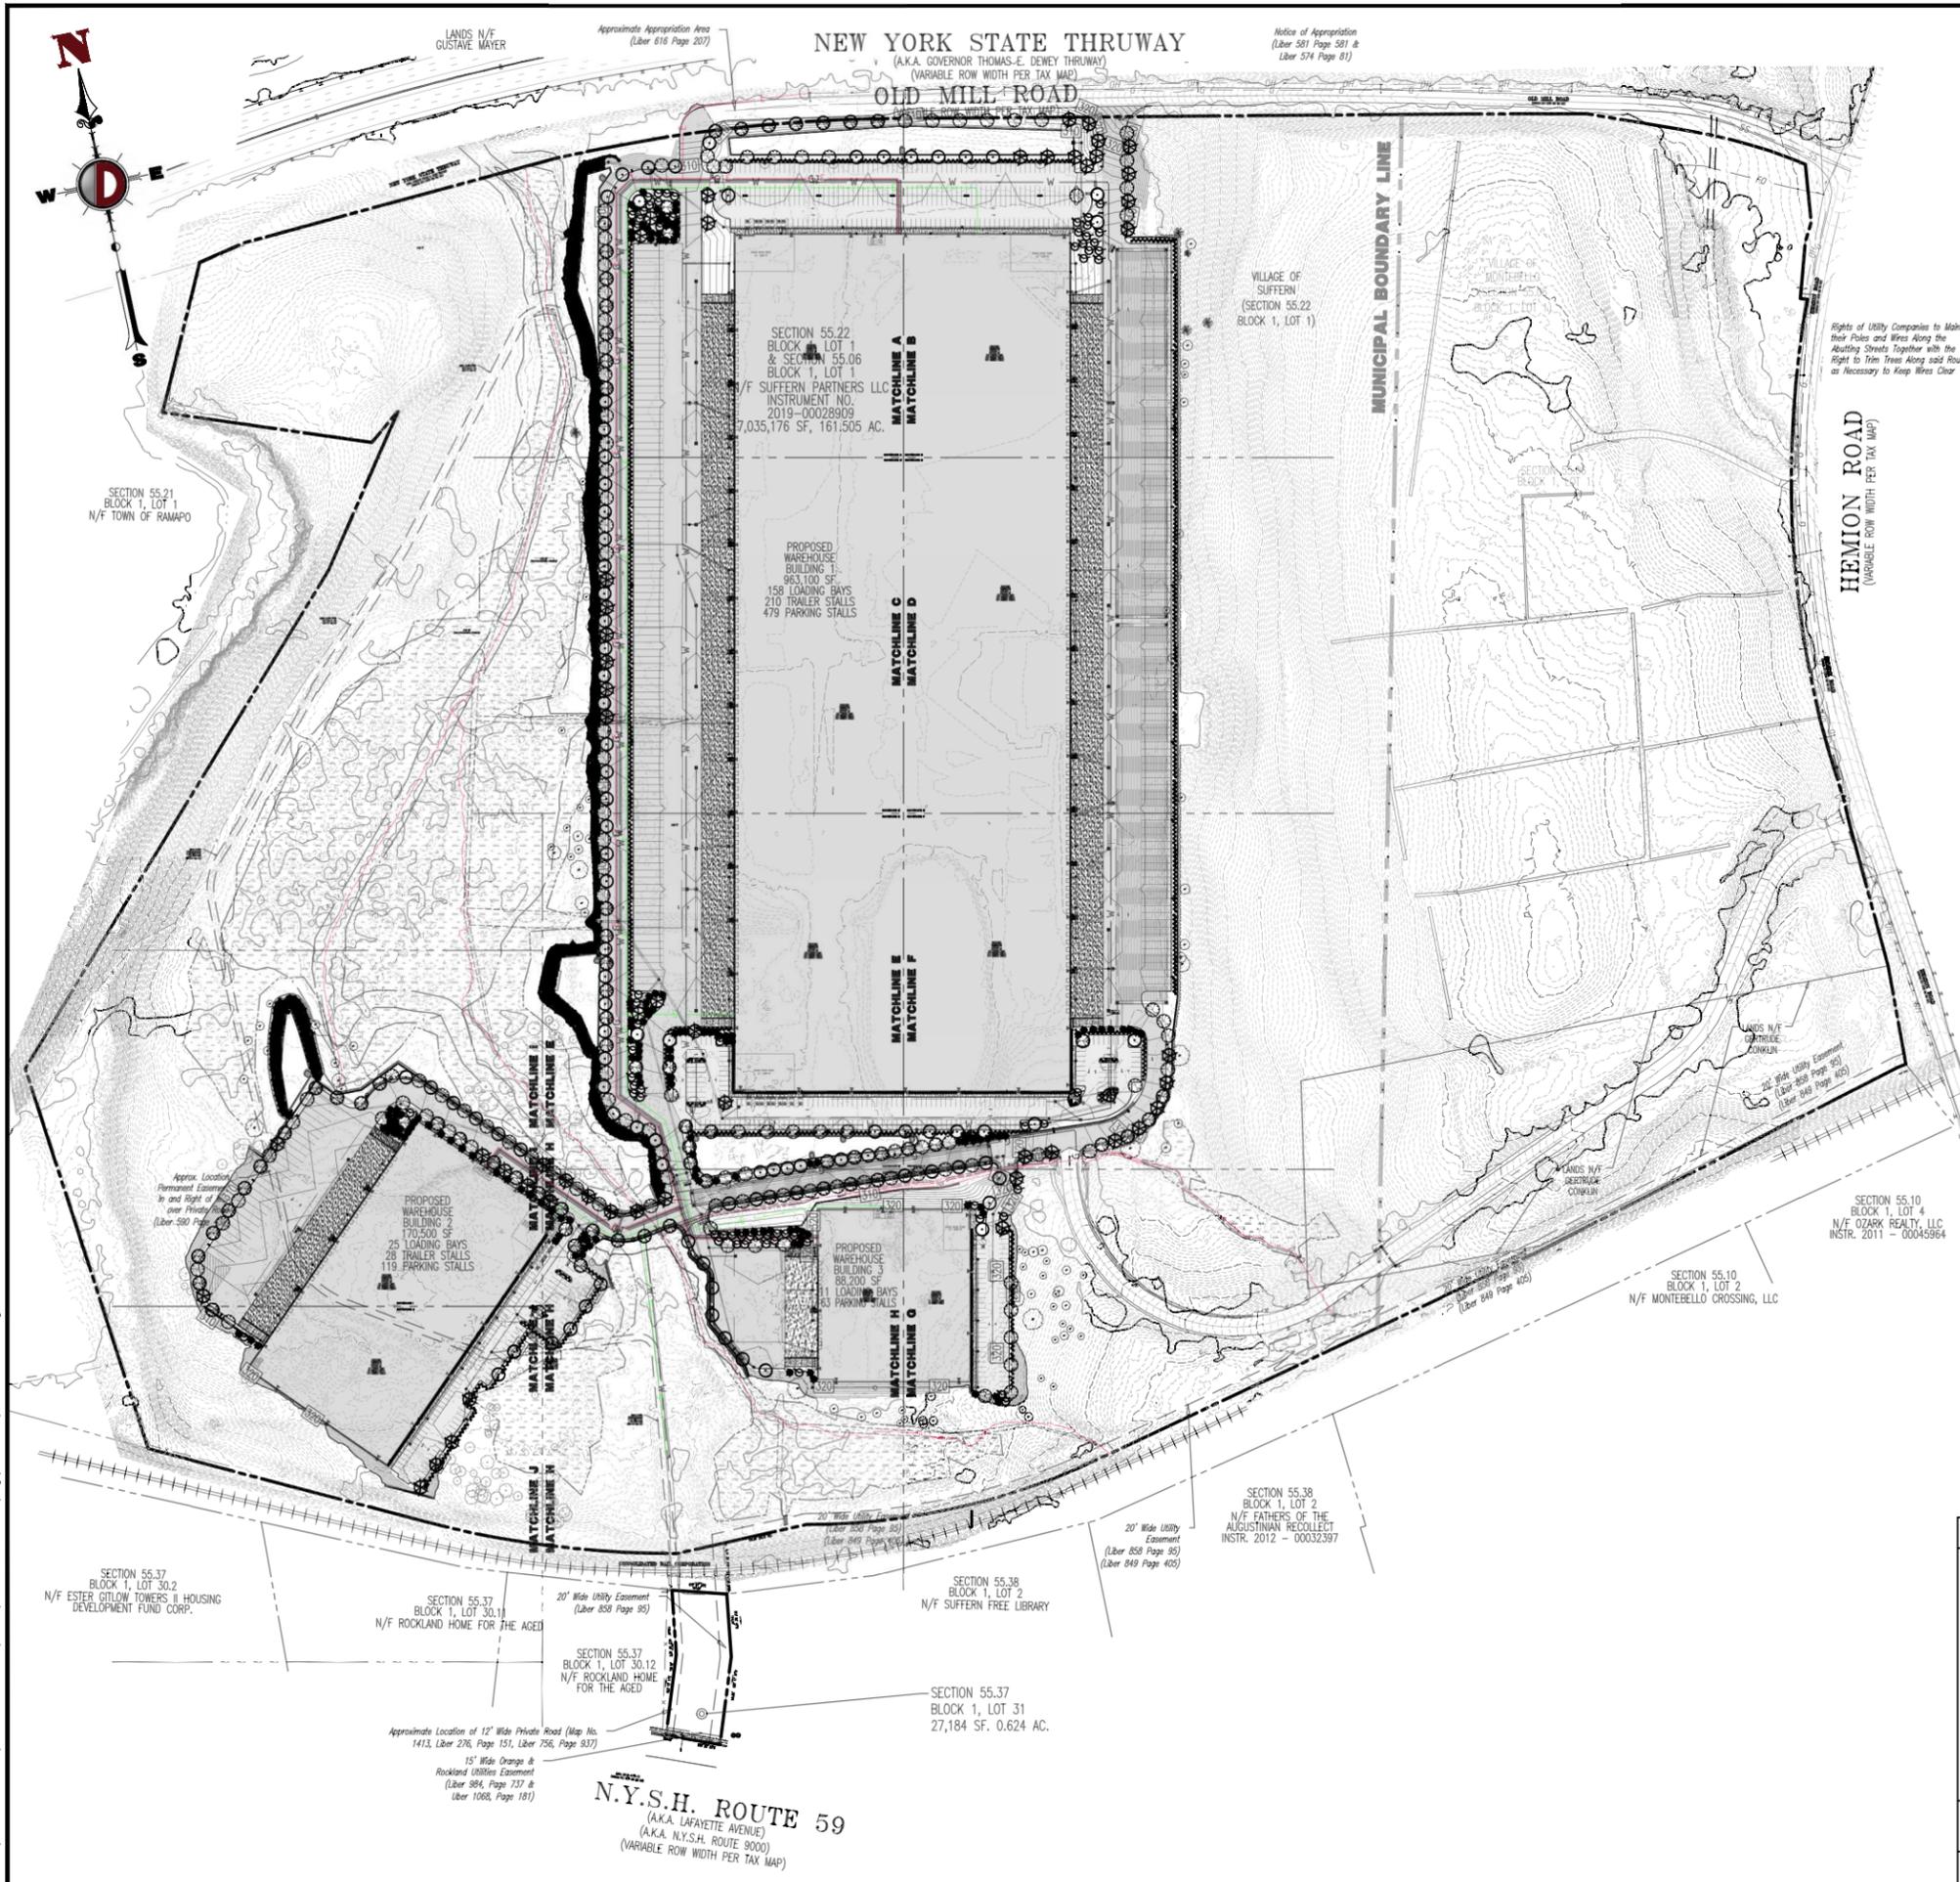
Figure III.B-6: Overall Landscape Plan

**Figure III.B-6**, Landscaping Plan, depicts the landscape plan for the Project Site showing proposed tree and shrub planting areas, as well as their design intent and function. Landscaping Plans are also provided in **Appendix C, sheets 60 through 71**. These species and their intent are summarized in **Table III.B-3**. Tree and shrub species of plants native to New York have been selected to the extent practicable for landscaping, soil stabilization, and stormwater mitigation features. Additional factors for plant selection included plant adaptability to local climatic conditions, including temperature,

precipitation, and length of the growing season. Many native species selected for planting may also be beneficial to indigenous wildlife, especially birds, by providing wildlife benefits such as nesting, cover, and food. Typical plantings that may be chosen for their hardiness to the local climate and to the proposed settings on the site include native or regionally adaptable landscaping species.

With the Proposed Project there would be substantial tree plantings that would provide a variety of foraging, nesting, and shelter benefits for the wildlife throughout the residential development. Trees that are planted would mature in the long-term and would provide roosting and nesting opportunities for birds that are adaptable to urban conditions.
